The 1957 Peace River Bridge Collapse, Taylor BC

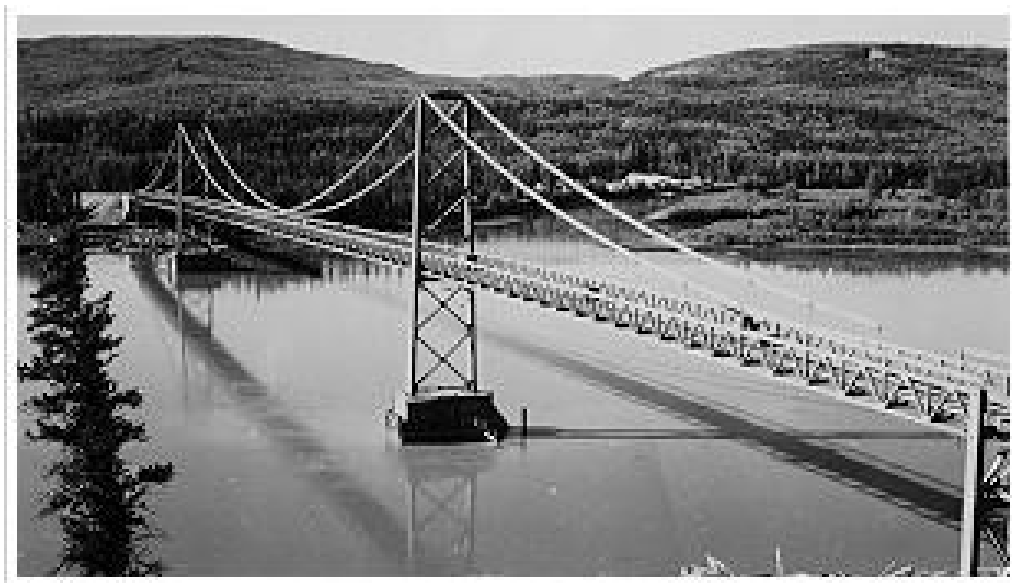
The suspension bridge over the Peace River near Taylor BC (1942 to 1952)
